三浦均也 建築・都市システム学系教授

SOIL LIQUEFACTION: MECHANISM, DAMAGE AND COUNTERMEASURES

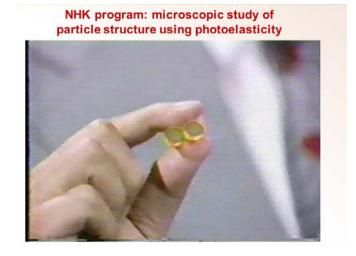
This video illustrates the photoelasticity experiment.

They used a cylinder made out of resin to resemble soil particles. You can see the array structure of soil particles and the modifications it suffers when stress is transmitted and the particles are subjected to vibrations. The translucent resin to which stress is applied becomes denser, which slows down the speed of light traveling along. This leads to monochromatic light interference that creates a striped pattern (alternating bright and dark bands). The linkage between these bands allows

us to know the status of stress transmission. This kind of experiment has been used also in mechanical engineering, but nowadays, computer simulation has made more detailed analysis possible. This video shows how soil liquefaction mechanism is impressively visible now.

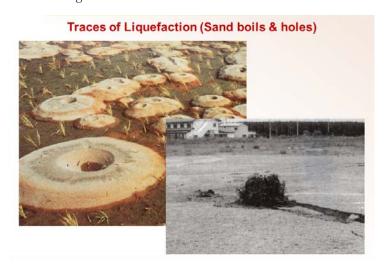
The images show a sand boiling and sand boil holes, which indicate traces (evidences) of liquefaction. These were observed in the Middle Japan Sea Earthquake.
